PROPERTY INSPECTION REPORT

**123 Main Street, Austin
John and Jill Smith**

Inspection date: Tuesday, August 1, 2023
Inspector: Matthew Kenny, Lic #09997
Buyer agent: Jane Doe

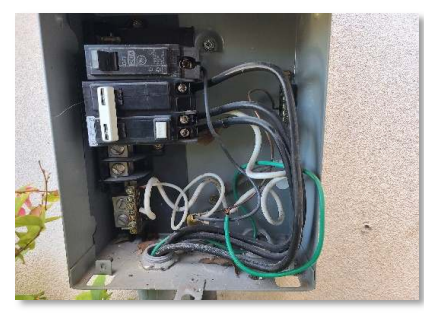
Interior of subpanel by rear patio

q. Ground wire inside rear patio subpanel is not connected to grounding bar. This should be investigated and repaired by licensed electrician.

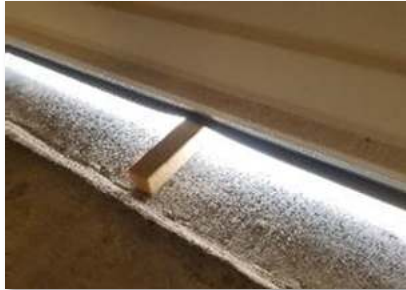
Item C (failed test)

- e. Wall button on 1st and 3rd garage door opener must be held down to get door to close. This typically indicates a misalignment of the infrared sensors or an improperly adjusted downforce. As the infrared sensors appear to be aligned, it is assumed the downforce setting must be increased or the seller's belongings disrupt the beam. Service and further review recommended.
- f. Light bulbs on all 3 garage door openers require replacement.

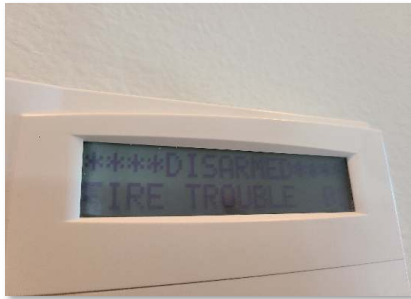
Item B

- Alarm control panel displayed several error messages and requires service.
 - Wiring for primary shower window alarm was protruding through wall of shower and should be capped back into wall.
