PROPERTY INSPECTION REPORT

**123 Main Street, Austin
John and Jill Smith**

Inspection date: Tuesday, August 1, 2023
Inspector: Matthew Kenny, Lic #09997
Buyer agent: Jane Doe

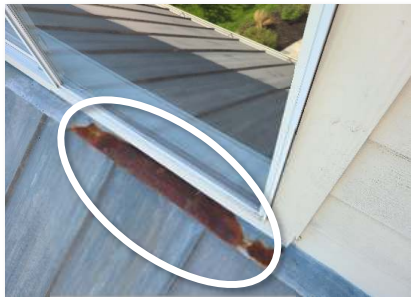
Item H

- h. NOTE - staining observed on metal roof outside of NE guest bedroom (due to prior leak from HVAC overflow) and to east of enclosed balcony window. Noted for record.

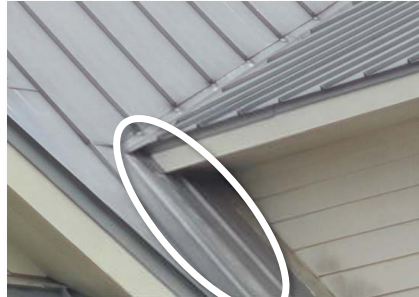
Item H (by converted balcony)

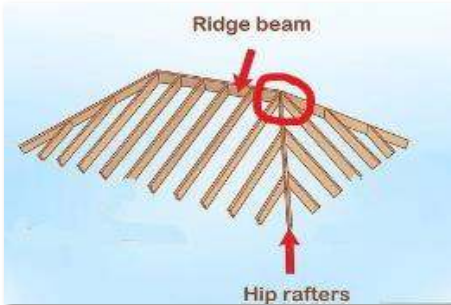
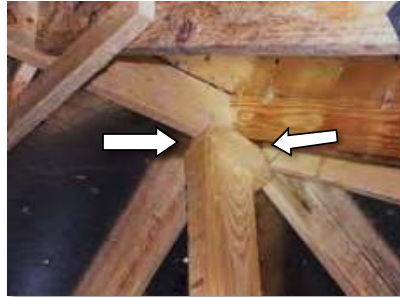
Item F (location of palm brace)

Item F (typical palm brace)

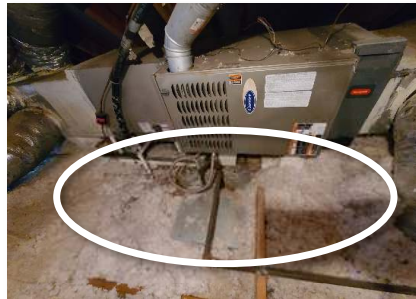
Item K

- j. LIMITATION - Inspector unable to access scuttle hole cut into front patio due to lock.
- k. A working platform 30" deep is required in front of HVAC units for servicing. Missing at eastern HVAC unit.

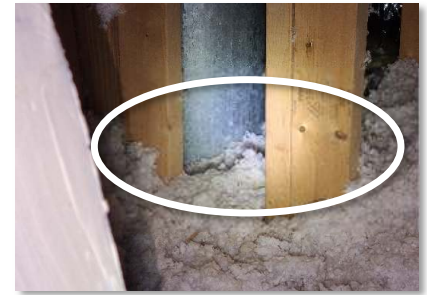
Item L

- l. Insulation and other combustibles should be kept at least 2" away from chimney flues. Insulation was found resting against chimney flue.
- m. Evidence of prior leaks observed around chimney enclosure inside attic (appears repaired). As mentioned in roof section of report, light staining to plywood decking observed below eastern HVAC furnace flue.

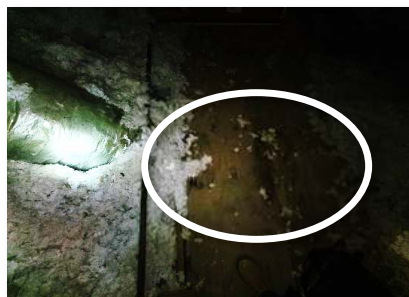
Item M (below furnace flue)

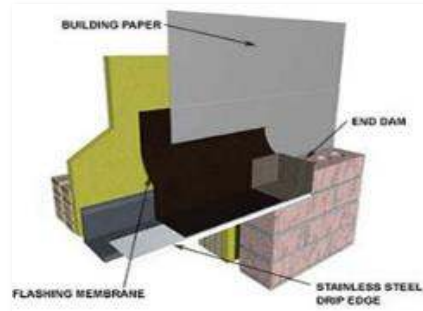
Item E (window flashing detail)

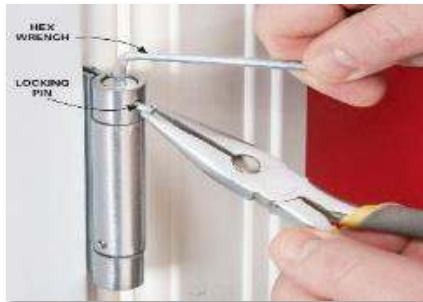
Item C (sample photo of self-closing hinges)

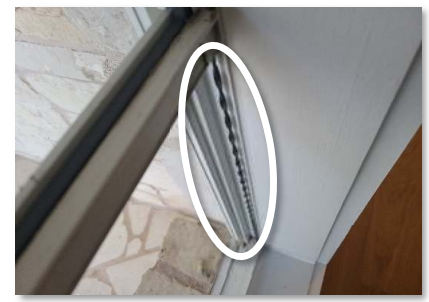
Item H

- h. Torsion bar/spring of dining room and both breakfast nook windows is detached from window frame. Although this does not greatly affect window operation, it is noted for record.
- i. Recommend caulking touchup at voids around exterior of all masonry windows to prevent water penetration and air infiltration.
- j. Holes have been drilled through the window sill to accommodate installation of security alarm contacts. These holes void most manufacturer's warranties. While this is extremely common and alarm contacts are well sealed with silicone, it is noted for record.
- k. NOTE - window screens have been removed from all windows. Inspector could not verify quantity; it is advised buyer request seller to confirm screens are available for all windows.

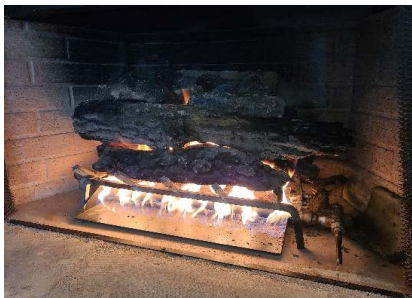
Fireplace in operation (OK)

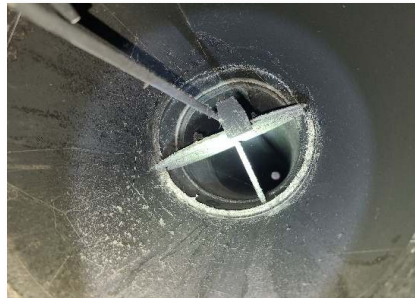
View up fireplace flue (OK)

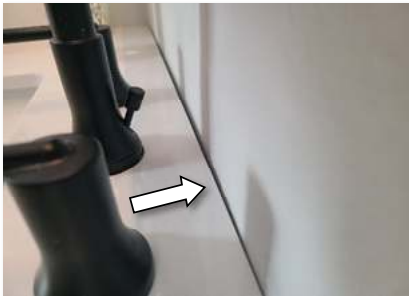
Item B

- 1. Kitchen countertop material: Granite Solid Surf / Quartz Laminate _____
- 2. Soft-close doors / drawers: Kitchen Bathrooms None (not required)
- 3. Comments:
 - a. NOTE - reviewing for proper fastening of cabinets to walls is not part of this inspection.
 - b. Laundry bath countertop should have backsplash added or be caulked to wall to prevent splashed water from falling behind cabinet.

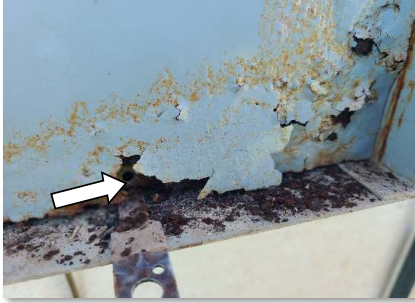
Item G

- f. Exterior service panel required to be sealed to wall to prevent water from entering panel and to prevent water from entering home through penetration between panel and home.
- g. Deadfront cover of exterior subpanel is heavily corroded at bottom edge. Deadfront is missing a screw to secure cover in place. Recommend adding.
- h. NEWER CODE - NEC 2017 standards require exposed ground wires be protected with rigid conduit.

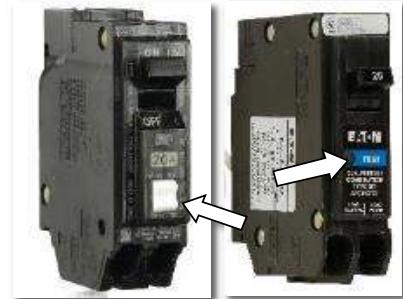
- j. NEWER CODE - Beginning with homes built after 2002, bedrooms should be protected with Arc Fault Circuit Interrupters (AFCI's). For homes built after 2015, all conditioned rooms (excluding bathrooms) should be protected with AFCI's. AFCI's protect against arcing of electricity in the circuit, which may lead to fires. Currently, home is not equipped with AFCI's.

Item J (sample photo of AFCI breakers)

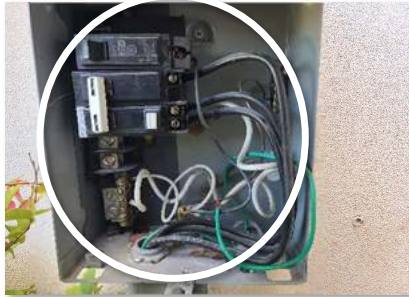
Item O

o. Subpanel on wall by rear patio is missing its protective deadfront cover. This is required to prevent inadvertent shock and must be replaced.

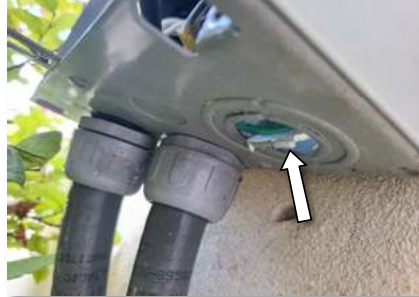
Item P

p. Open knockout at bottom of service panel is required to be sealed to prevent pest entry.

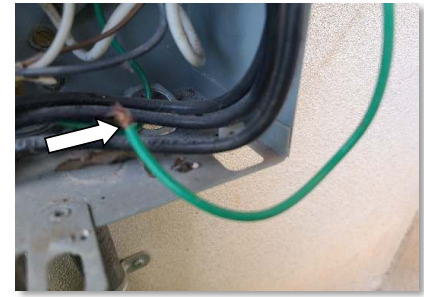
Item Q

q. Ground wire inside rear patio subpanel is not connected to grounding bar. This should be investigated and repaired by licensed electrician.

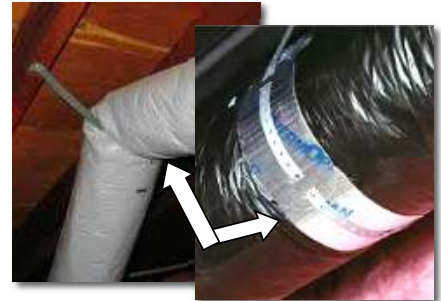
Item F2 (saddles can prevent crimping)

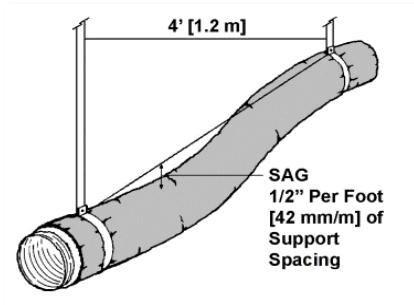
Item F3 (allowable sag)

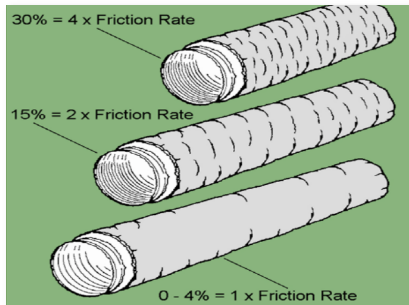
Item F4 (loss due to not pulling tight)

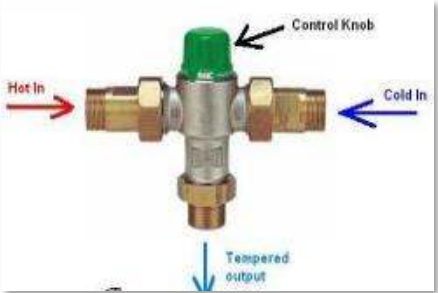
Item L (example)

- l. NEWER CODE - Thermostatic mixing valves are required by newer building standards only in tubs with separate hot & cold handles to limit water temperature and prevent scalding. No thermostatic mixing valve was found; this was not typically installed in older homes.

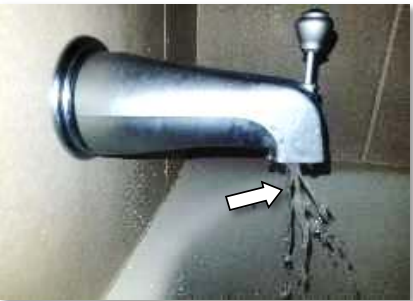
Item M (example)

- m. Nearly all tub spouts drip when showerhead is running. This is an extremely common item caused by a calcium buildup or an imperfect seal at the tub spout diverter valve. If dripping becomes extreme over time, spout can be replaced.

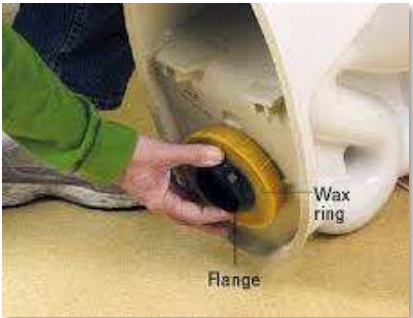
Item N

- n. Grout void at inside face of primary bath shower curb should be sealed to prevent water entry.
- o. Upper east bath toilet is not secured and sealed to floor. This can damage wax ring and cause sudden leakage. Toilet should be removed to inspect condition of wax ring and floor flange and then fastened and caulked to floor. (no active leak noted at time of inspection)

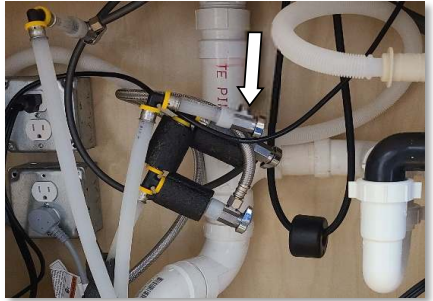
Item P

- p. Primary bath toilet is not sealed to floor- recommend repair to prevent fouling of joint and possible loosening of toilet.
- q. Unused water line under kitchen sink should be capped to prevent leak should valve be inadvertently turned on.

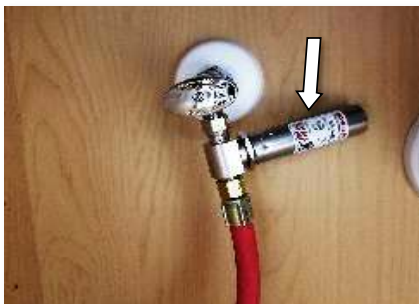
Item B

- b. NEWER CODE - Water hammer arrestors are required under current standards on all dishwasher hookups (IRC P2903.5) and are recommended on older hookups.
- c. Dishwasher drain line must be raised to underside of the counter (not the underside of the sink) to prevent backflow of dirty sink water into a clean dishwasher.

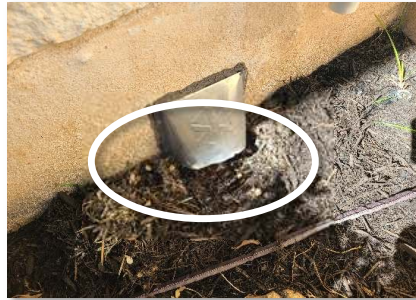
Item D

- d. Dryer exhaust exits foundation at grade level and is being obstructed by garden mulch. Mulch should be cleared away and access kept open.

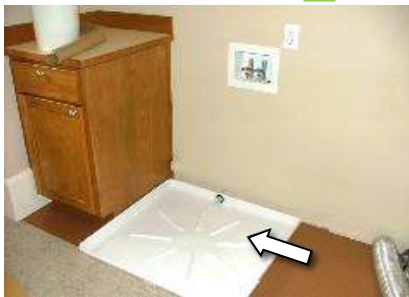
Item E (example)

- e. Drain pans are recommended (but not required) under clothes washers in the event of leaks/spills. A drain line is not present in the wall for this purpose and would need to be added.
- f. Water hammer arrestors are required under current standards on all clothes washer hookups (IRC P2903.5) and are recommended on older hookups.
- g. Hot water connection at clothes washer is dripping. Valve should be replaced as the drip will only worsen over time and may not shut off during next washer disconnect. At a minimum, valves should be capped until a washing machine is hooked up to prevent possible water damage in wall.

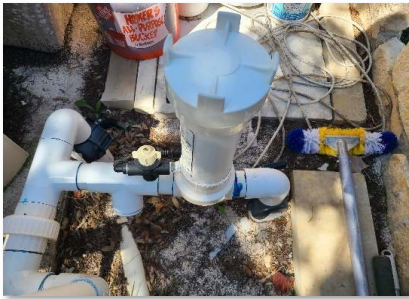
Photo of water sanitization device (OK)

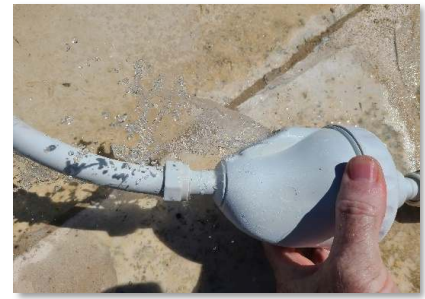
- f. Robotic cleaner is functioning with minor leaks to hose joints (typical). Leaf bag and water suction jets were found in proper operating condition. Reversing valve was observed to operate cyclically and in-line water filter was noted at end of hose. Cleaner is not disassembled to examine internal components.
- g. Robotic cleaner has low pressure to internal jets that drive wheels and suction as well as low pressure to reversing valve. Inspection revealed that the attachment of the supply hose to the pool wall was loose and allowing significant pressure to escape, which affects overall function of cleaner. Recommend repair.
- h. Normal wear and tear to robotic cleaner tires. These require periodic replacement every few years along with interior gears and belts.

Photo of robot reversing valve operating

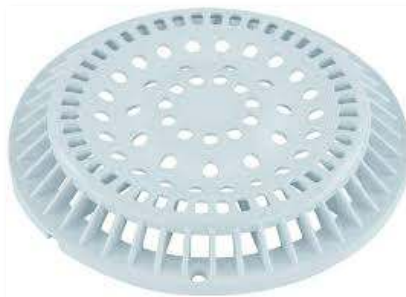
- a. NOTE - Modern pool safety standards require at least two drains in each body of water per the Virginia Baker Act to prevent accidental drowning. If this is not feasible, an anti-suction or raised drain cover is recommended. Pool and spa are equipped with dual drains and raised drain covers.
- b. Steps and other abrupt changes in elevation inside the pool are required to be marked with tile, paint or other identifying marker.
- c. NOTE - No significant cracking to plaster was observed that would be considered detrimental to pool function.

Item A (raised anti-suction cover)

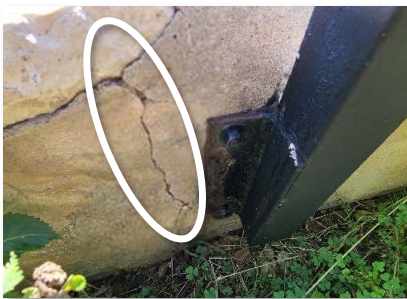
Item D

- d. Crack to exterior bond beam of pool at NE corner of shallow end (by planter). Crack does not exceed 1/8" in width and does not appear to be leaking or causing adverse effects to the pool or decking. Noted for record.
- e. Railing on east side of stairway leading from rear patio to pool patio is not secured to wall (loose bolt).. Recommend repairing.
- f. Gate latch leading from patio stairs to pool only functions sporadically (must lift up on gate and then jiggle and lift handle simultaneously several times to operate). Recommend replacing.

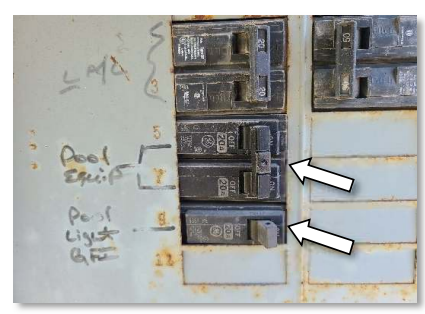
Item Q

- q. Breaker serving pool motors is required to be GFCI protected per 2014 NEC 680.21, even if the pool panel itself provides GFCI protection for underwater lighting.
- r. Timer for pool circulation pump is missing start/stop switches, allowing pump to run 24 hours a day. This is not necessary and will result in high electrical bills. Recommend installing start/stop switches and setting timer to above recommendations.
- s. Pool water was observed exiting top of pool lighting conduit inside pool equipment control panel. This will result in corrosion of panel and is a shock hazard. Control panel should be raised above level of pool edge to prevent this from occurring.
- t. Although not often installed, audible alarms are required by current standards on all exterior doors and windows leading to pool area.

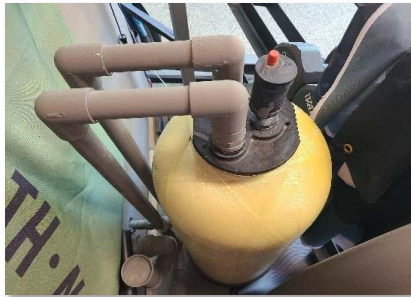
Item B

- a. BUYER NOTE - Plumbing loop has been installed in garage for potential future water softening system.
- b. BUYER NOTE - Inspector observed what appears to be a pressure tank for a water conditioning device installed in garage. Inspector is not licensed to evaluate these systems but no physical leaks were observed. Buyer may wish to familiarize themselves with product (Park International Corp Model #RT-1236-45) (https://gc2000.pl/wp-content/uploads/docs/PARK_Pressure_Tanks.pdf). It is unknown if this is simply the pressure tank for a larger (removed) system or serves as an ionization device for softening.

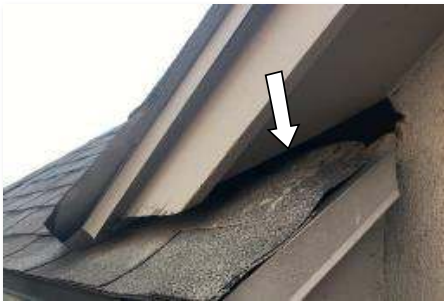
Item A (sample of rodent entry point)

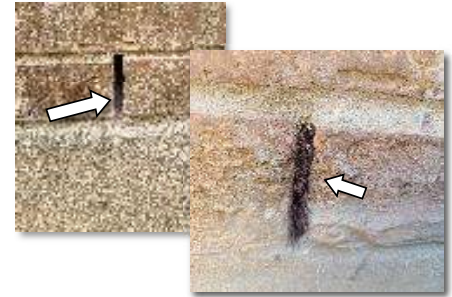
Item F (weep hole with & without mesh)

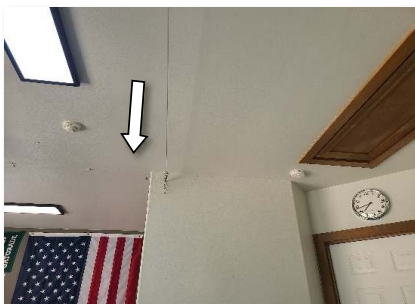
Item B

- a. NOTE - TREC does not require inspectors to comment on aesthetics. Any comments included below are purely for the client's information and is not a comprehensive listing.
- b. Stress cracking of drywall noted at garage (possibly from stepping off platform). Noted for record.
- c. Discoloration to upper east bath countertop, to right of sink.
- d. Scratch observed to tile to left of primary toilet.
- e. Ceiling is not painted around kitchen vent hood.
